Manhole Inspection Summary

Manhole # S21W__031MH

Insp Date: **11/5/08 12:09 PM**

Location Address: **2200 BERLIN ST**

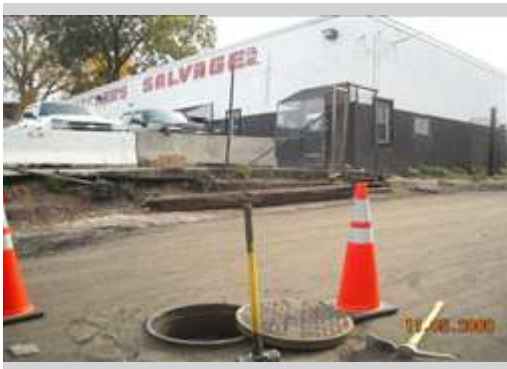
Location View

Comments **LOCATED @ DECKERS SALVAGE CO. INC. INFRONT OF SORTING AREA
REI/DRAYCO VISIT 11/10/08 REPLACED CRACKED COVER FROM PREVIOUS
INSPECTION. (see photos)**

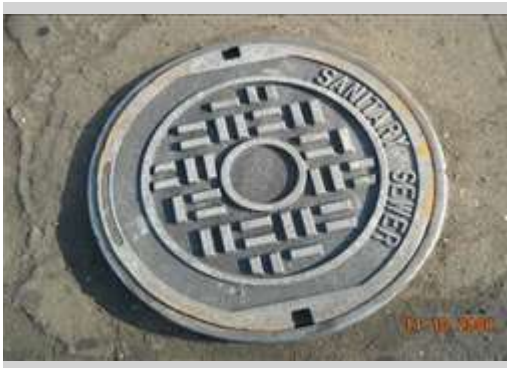
MISC.

NEW COVER

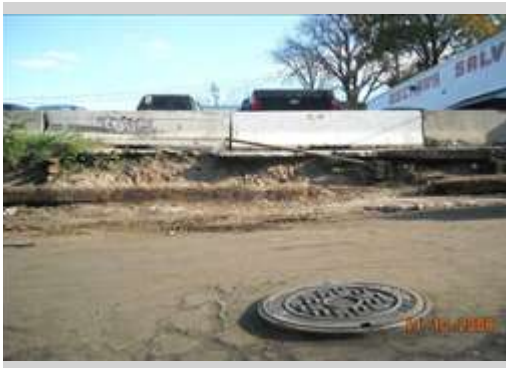
MISC.

LOCATION VIEW WITH NEW COVER

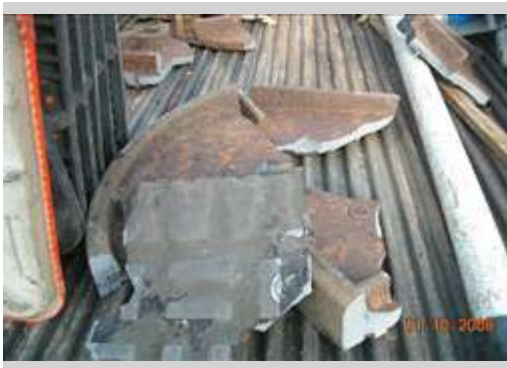
MISC.

BROKE CRACKED LID

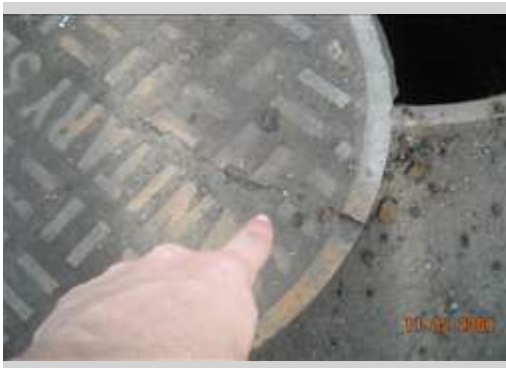
Miscellaneous

cover was cracked, then broken while opening MH, then replaced

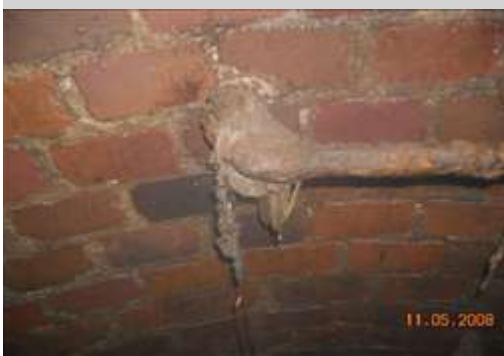
Defect 3

Steps Count: **11** Missing: **0** ☒ **Corroded**

Surcharge ☒ **Evidence Of Surcharge** Depth: **6** (ft.) ☐ Active Surcharge Present

SURCHARGE EVIDENCE, corroded step

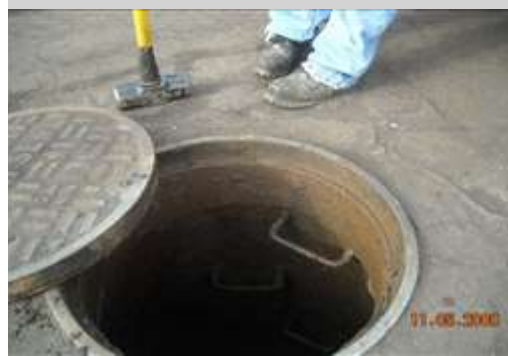
Defect

Frame Offset: **0** (in.) Condition: ☐ Sound ☐ Cracked ☒ **Leaks**

FRAME LEAKS_INFLOW EVIDENCE
FROM SHEETING

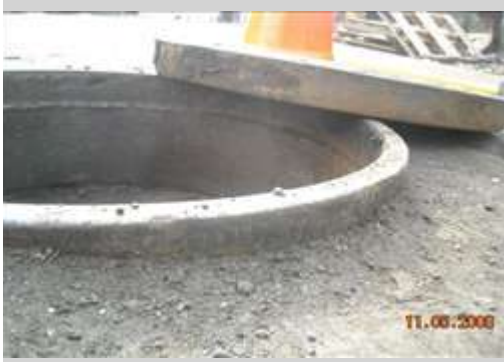
Defect 2

FRAME ABOVE GRADE

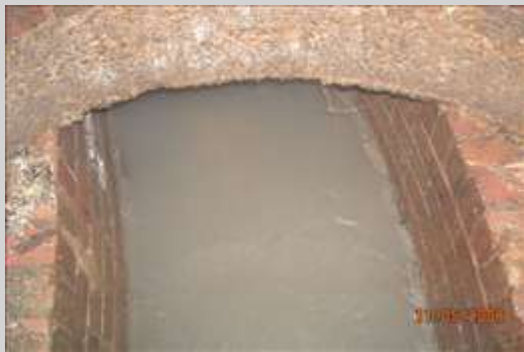
12 O'Clock Outflow

Pipe Height: **24** (in.) Rod and Bar (Angled)
Pipe Material: **Unknown** ☐ Pipe Lined
Invert Depth: **18.57** (ft.) Flow Characteristics: **Slow**
Deposits: ☒ None ☐ Mud ☐ Sludge ☐ Debris ☐ Grease
Silt Depth: **0** (in.) Deposits Extent:
Infiltration: **None** Pipe Seal Cond: **Sound**

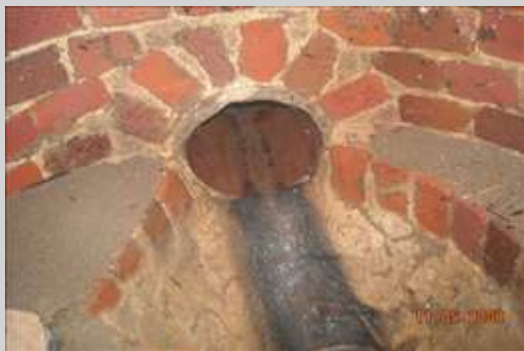
6 O'Clock Inflow

Pipe Height: **8.4** (in.) Rod and Bar (Angled)
Pipe Material: **Clay** ☐ Pipe Lined
Invert Depth: **7.42** (ft.) Flow Characteristics: **Slow**
Deposits: ☒ None ☐ Mud ☐ Sludge ☐ Debris ☐ Grease
Silt Depth: **0** (in.) Deposits Extent:
Infiltration: **None** Pipe Seal Cond: **Sound**

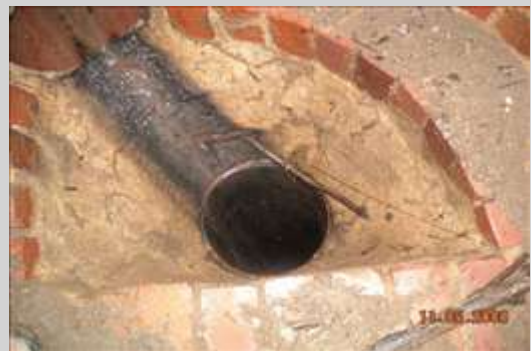
Drop In @ 6 OClock

Drop: **Inside** Rod and Bar
Angled: **Yes** Reading: **16.20** (ft.)
Inv Depth: **17.20** (ft.)
Drop Condition: **Open**

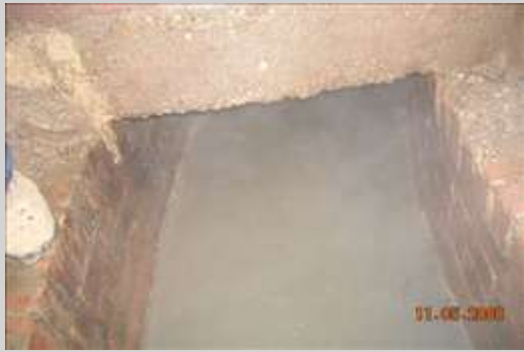
7 O'Clock Inflow

Pipe Height: **19.2** (in.) Rod and Bar (Angled)

Infiltration: **None** Pipe Seal Cond: **Sound**
